Michael STELMACH

1400 Session 6 Presentation from Sponsor

Ceramic Insulation Coatings in the Industrial Environment: What You Need to Know

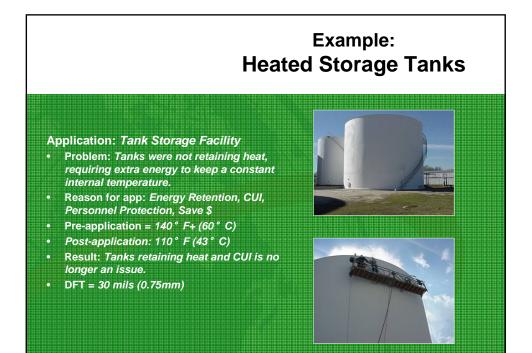
Example: **Oil Storage Tanks**

Application: Crude Oil Storage Tanks

- Location: St. Charles, LA
- Vessel name: 150-4, 150-5, 150-6
- Reason for application: energy retention, CUI (CUI so bad that when the inspector drilled through insulation, the drill went through the sidewall of the tank).
- Results: no CUI, calculation was performed to show the same energy saving as 1 ½" (4 cm.) of sprayed foam
- Photo location: any tank completely white and hurricane damage.
